DIOCESAN ADVISORY COMMITTEE

Arboricultural Report

Wellingtonia Tree in churchyard of St James Goffs Oak

CCTV REPORT

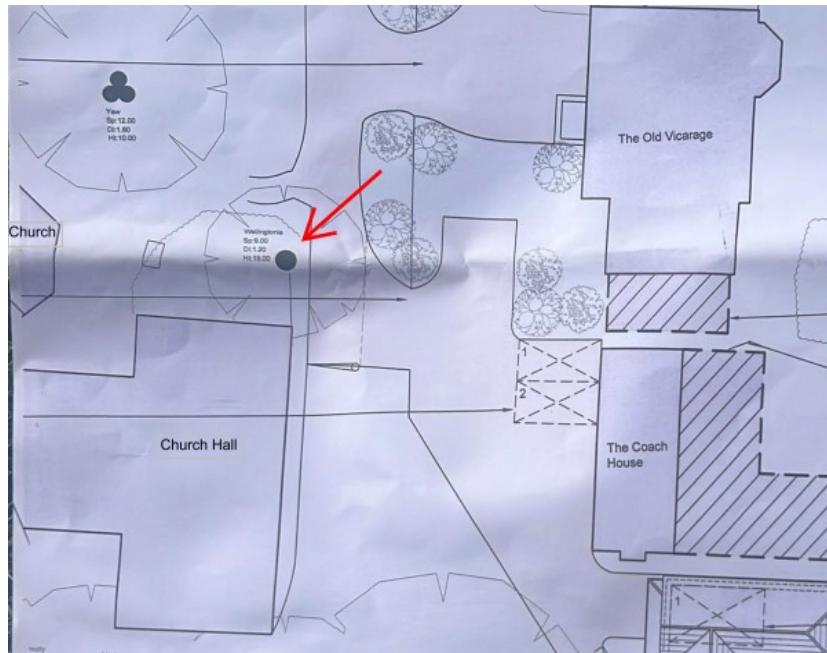
Location of Wellingtonia Relative to Church Hall and Church

The Wellingtonia in St James Churchyard is believed to be about 100 years old, and currently estimated to be about 20m high, with a trunk diameter of 1.5m. It appears to be in good health.

Its location is about 2m from the north face of the church hall, and about 11m from the east face of the church.

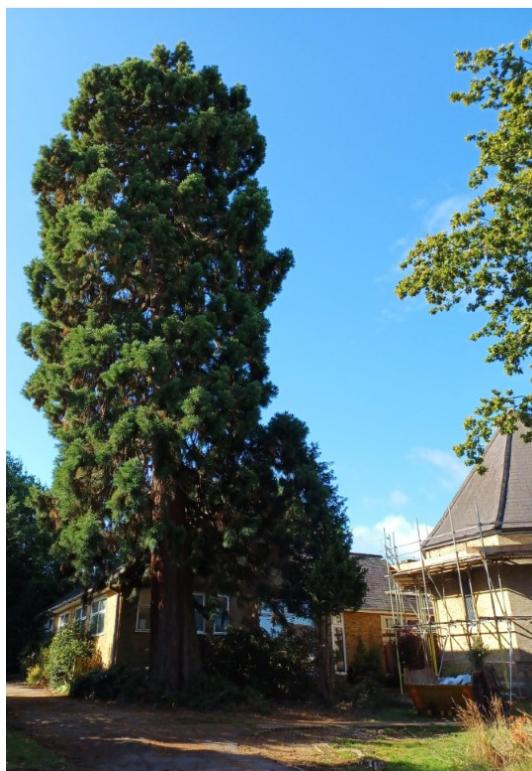
Wellingtonia in front of North Face of Hall with Church to the Right

The church hall has suffered from settlement movement and cracking in walls for many years. The ground bearing floor slab has settled, causing severe cracks to appear in internal partition block walls built off the ground floor slab.

Cracking is also evident in the external load bearing cavity masonry walls.

Recent repair work to the church hall steps on the north face revealed extensive tree root growth below the steps. This resulted in the steps having to be rebuilt on a new foundation.

For the tree to remain, the church hall would need to be demolished and rebuilt further away from the tree on deeper foundations. The existing below ground drainage system would need to be diverted and rebuilt away from the tree. Consideration should also be given to the installation of a tree root barrier system to protect the church footings.

If the tree were felled, this would present more options for the re-use of the existing church hall site and existing below ground drainage system, while also safe guarding the church itself. Felling is therefore the preferred option.

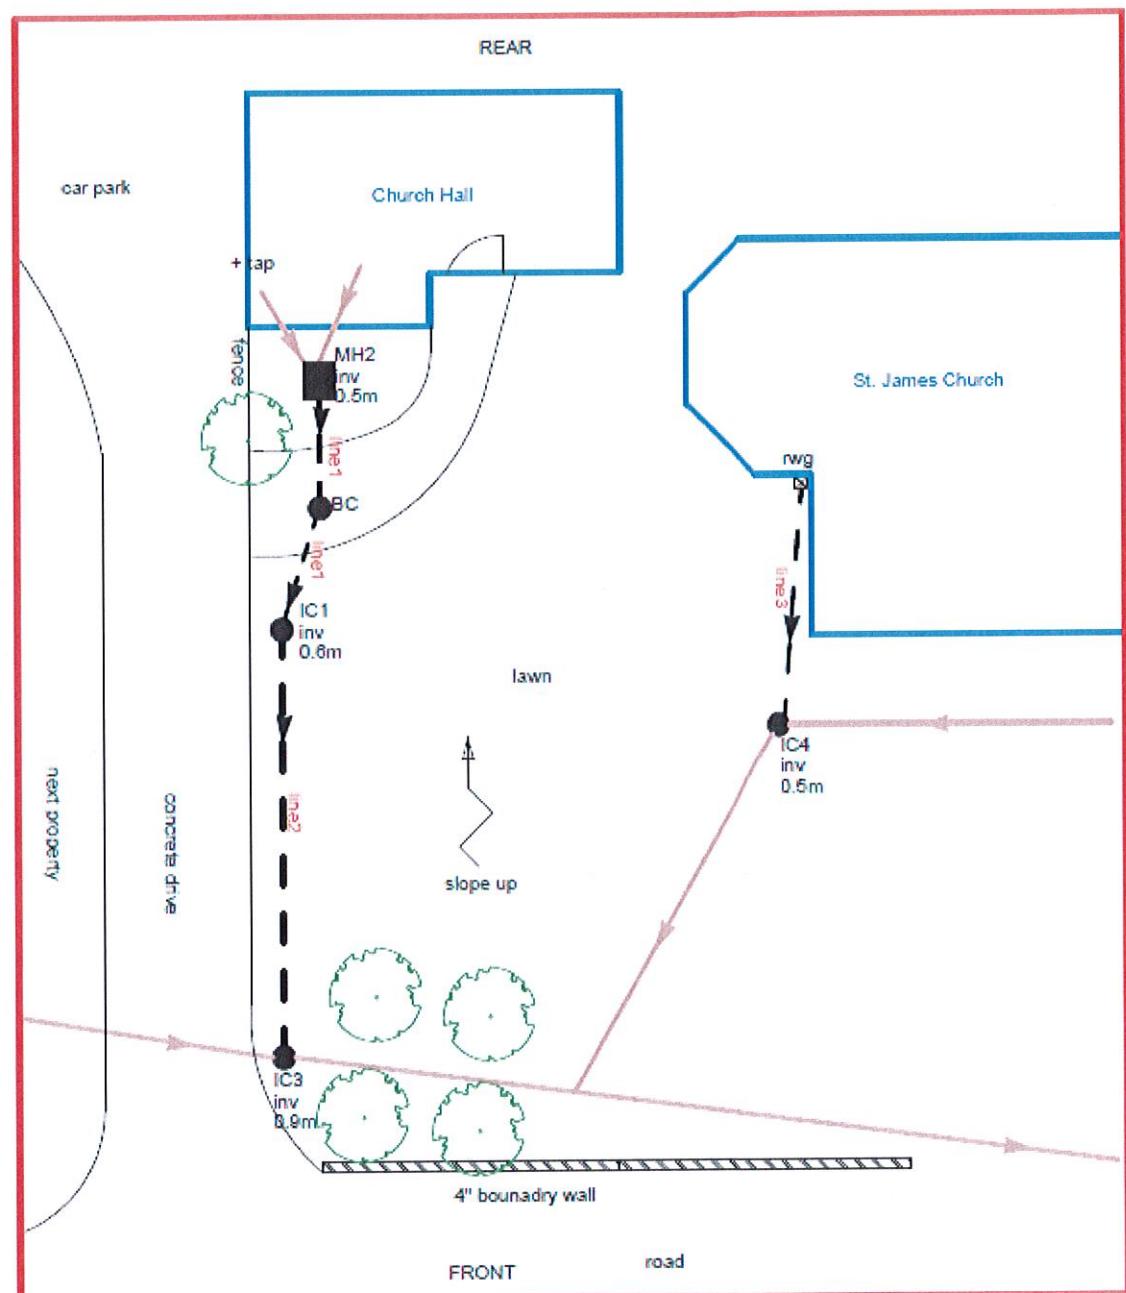
EXISTING DRAINAGE LAYOUT

- A CCTV investigation into line 1 from IC1 upstream to MH2 found a buried IC approx. 5m downstream. A deformity was then noted in the line approx. 12m downstream.

- A CCTV investigation into line 2 from IC1 downstream to IC3 found roots in the line approx. 17.3m downstream. Jetting was used in an attempt to clear the line however this did not resolve the issues.

- A CCTV investigation into line 3 from IC4 upstream to the RWG found roots in the line from 0-4m downstream. A joint displacement was then found approx. 5.7m downstream. The roots were removed at the time of the investigation.

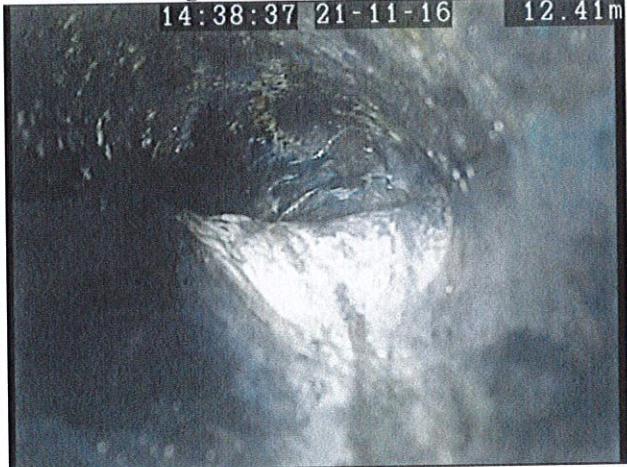
Fig 1.1 – line 1 deformity

- Excavate and replace 1m of 100mm pipework from MH2 upstream. This will involve an excavation to a depth of less than 1m and will be reinstated in turf.
- PLEASE NOTE – some of the bushes in the area may have to be cut back to facilitate the repairs. The Californian red wood may have caused root ingress in the line which will have to be cut through.

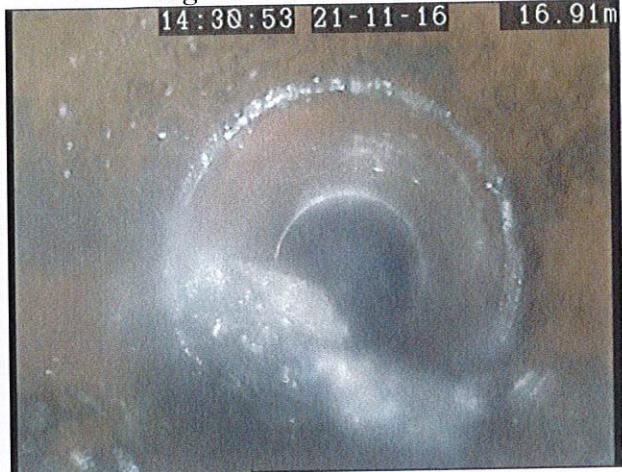
Fig 1.2 – roots in the line

- Excavate and replace 1m of 100mm pipework from IC3 upstream. This will involve an excavation to a depth of less than 1m and will be reinstated in turf.

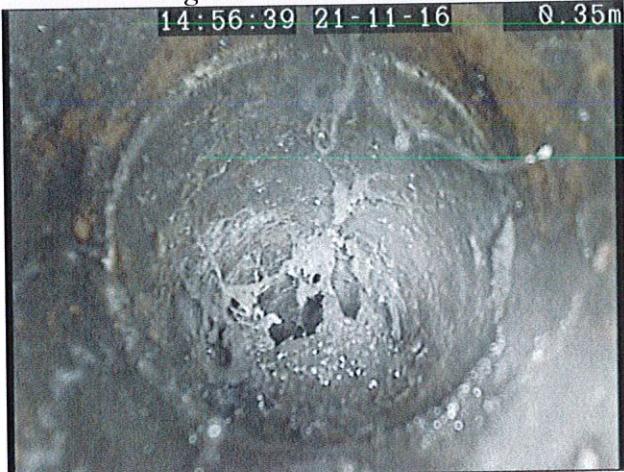
Fig 1.3 – roots in the line

- Excavate and replace the RWG and 1m of 100mm pipework downstream. This will involve an excavation to a depth of less than 1m and will be reinstated in turf.
- From the excavation install approx. 6m of 100mm liner downstream to IC4.
- We have advised the insured that their claim for accidental damage to the underground services is accepted as there are insurable defects to the private underground drainage serving the building.
